DRAFT
Analysis of Brownfield Cleanup Alternatives
Former Don's Market
Lakeview, Oregon

Prepared for:
Oregon Department of Environmental Quality
Task Order No. 66-23-27

May 15, 2026
25013603/Task 5

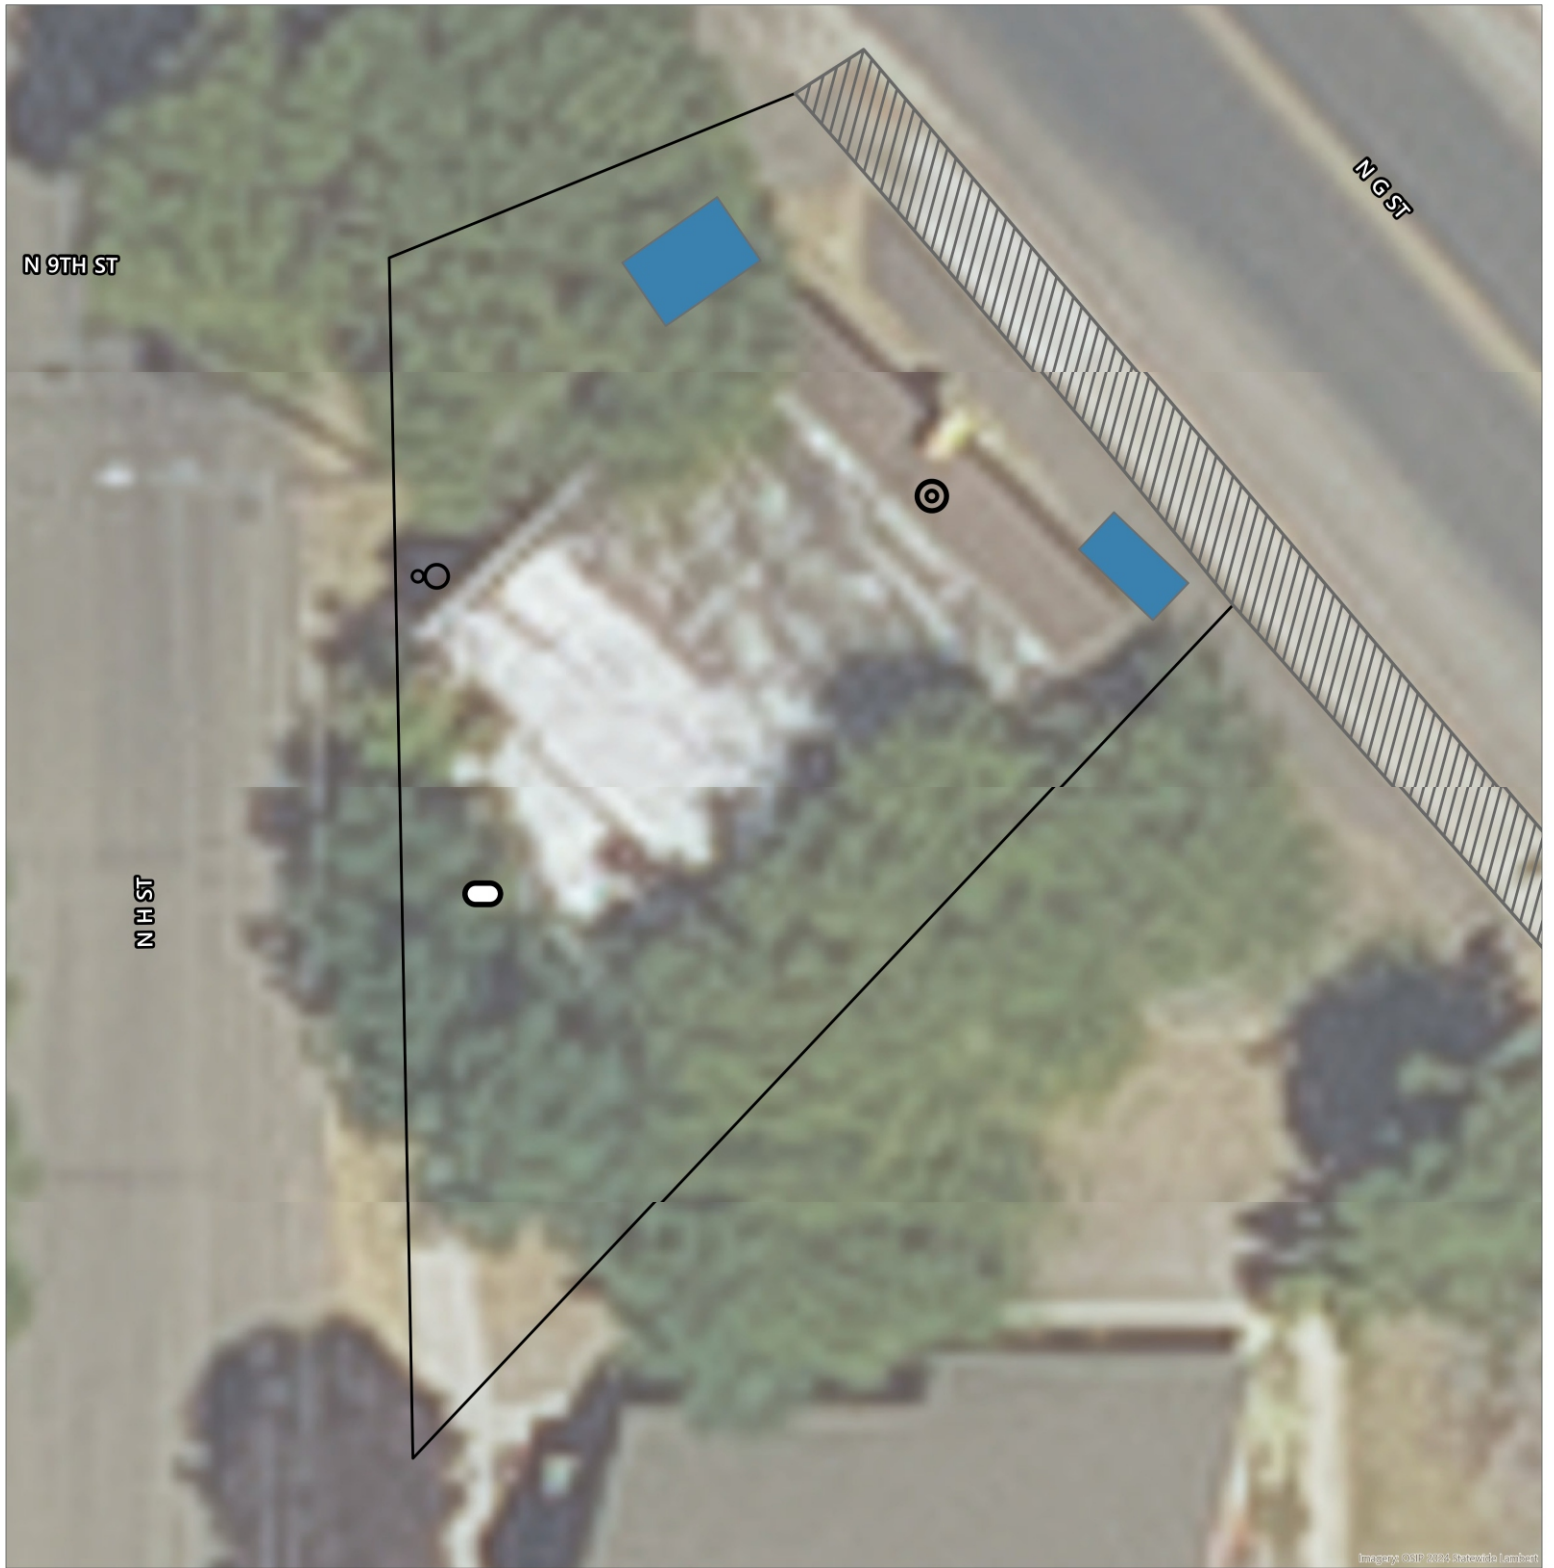
Alternative 4 Conceptual Layout

Alternative 4 —UST Decommissioning in Place and No Active Soil Treatment. In this alternative, the USTs will be decommissioned in place, and the petroleum-impacted soil will be managed only with institutional and engineering controls. Natural processes would be expected to reduce petroleum hydrocarbon concentrations through microbial degradation or other similar processes (documented through MNA). Permanent land use restrictions would be required for future use of the property and long-term monitoring would be needed to assess potential exposures. As residual contamination will remain at the Site in the vicinity of the USTs, a Contaminated Media Management Plan (CMMP) should be prepared to address the proper handling and disposal of any contaminated soil that may be encountered during future construction or development at the Site.

Alternative 4 —UST Decommissioning in Place and No Active Soil Treatment. Decommissioning the USTs in place would ensure that continued or future releases from abandoned USTs would not be possible at the Site. This alternative does not address historical releases or current soil conditions and would be less reliable in controlling the risk to human health or the environment posed by the petroleum-contaminated soil at the Site as it would rely on long-term natural processes that are relatively slow. Exposure to remaining concentrations of petroleum-impacted soil at the site may be managed with institutional controls (such as use restrictions and a Contaminated Media Management Plan (CMMP)) and inclusion of vapor controls on future development.

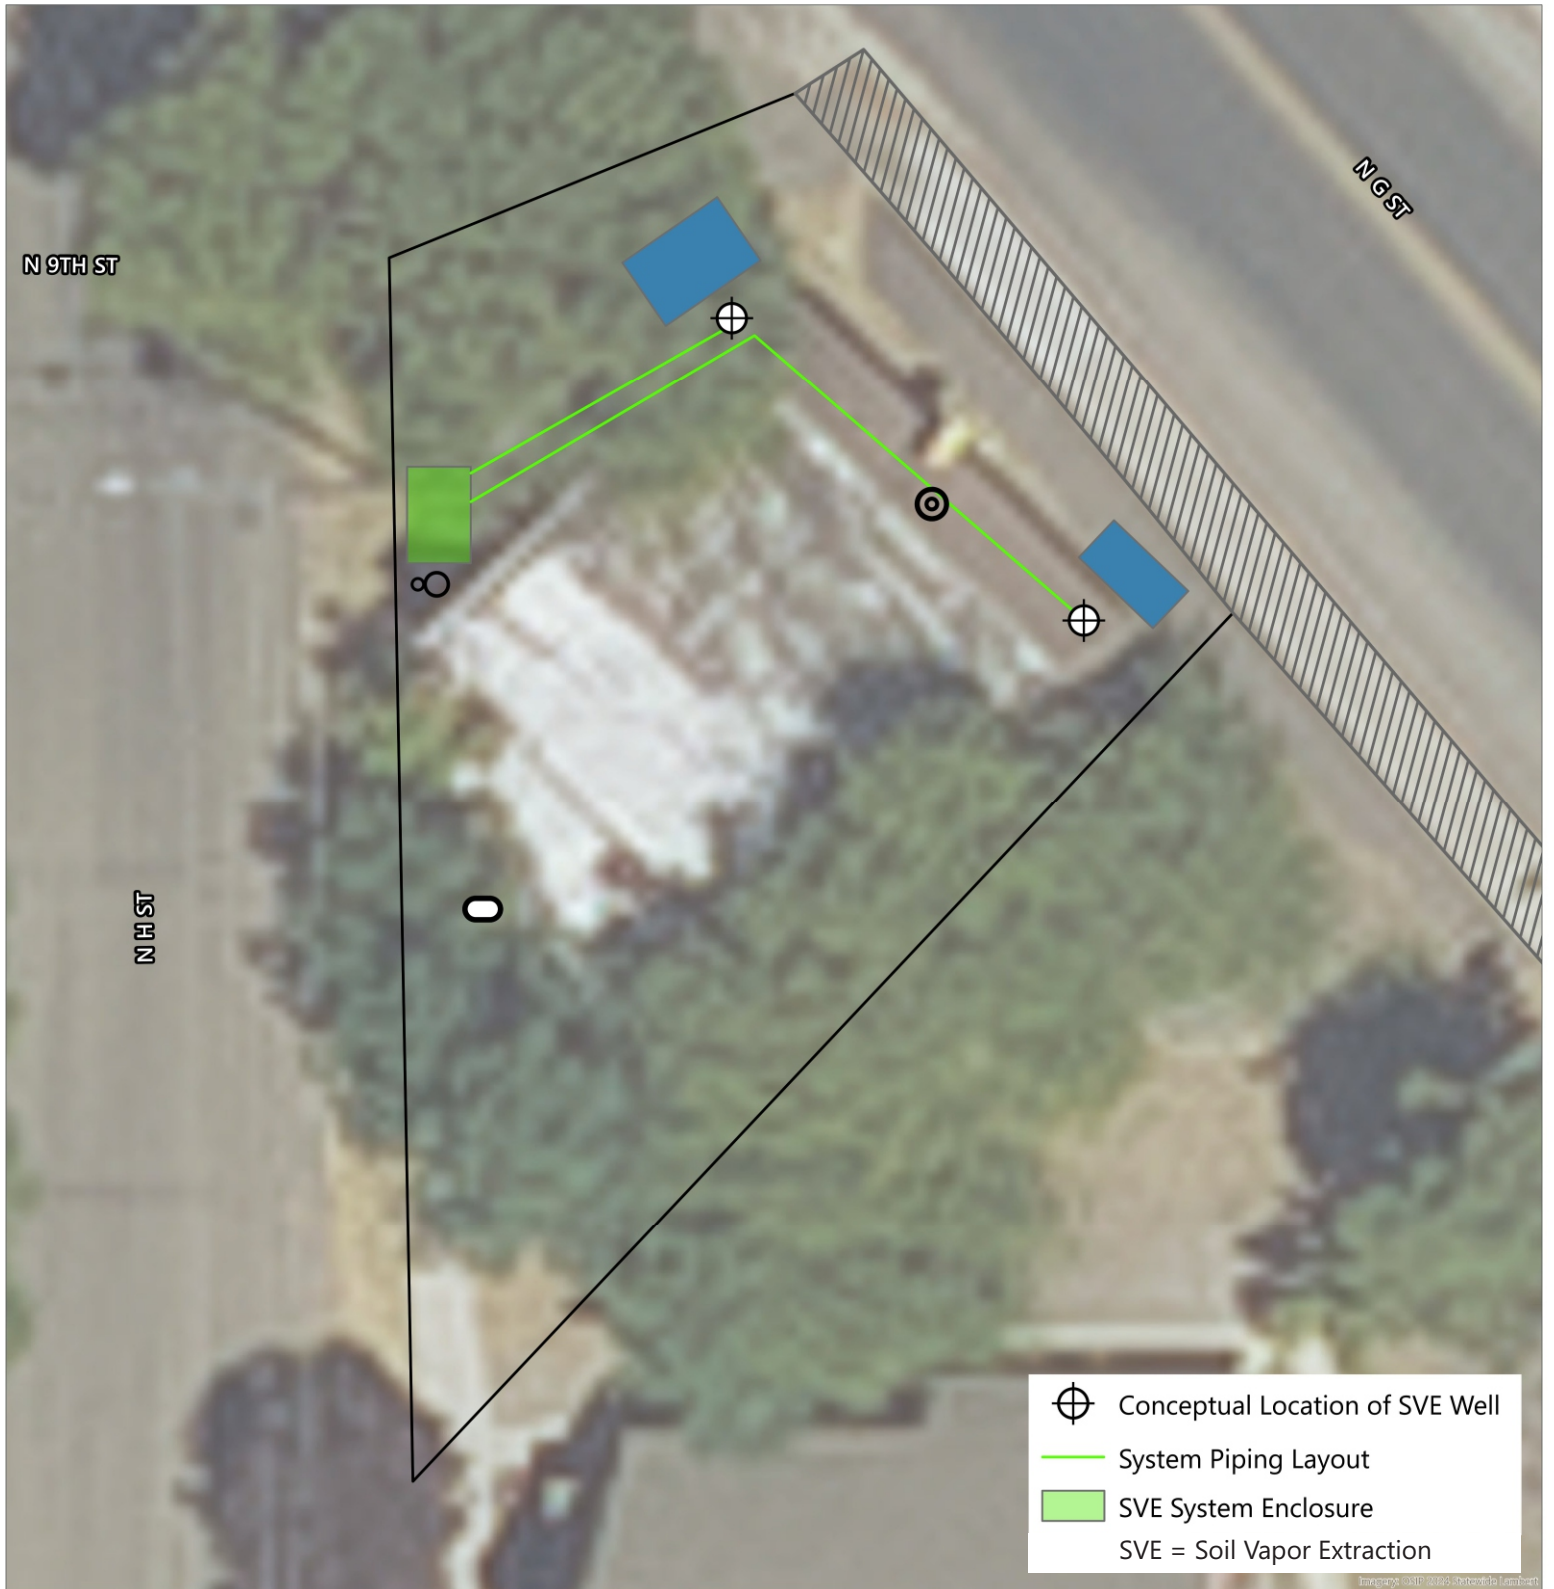
Alternative 5 Conceptual Layout

Alternative 5—UST Decommissioning in Place and In Situ Treatment of Petroleum-Impacted Soil. In this alternative, the USTs will be decommissioned in place, and the petroleum-impacted soil in the vicinity of the fuel island will be treated in situ. For the purpose of the alternative, the in situ technology is soil vapor extraction (SVE; an in situ alternative that is likely to be relatively cost-effective given the Site conditions), and it is assumed a total of 250 cubic yards of soil at the Site will be treated in situ. This alternative would require the construction and operation of a treatment system (essentially comprised of a vacuum blower, moisture separator, and potentially vapor treatment such as activated carbon vessels). Land use restrictions and monitoring would be required until soil cleanup goals are met. As residual contamination will remain at the Site in the vicinity of the USTs, a CMMP should be prepared to address the proper handling and disposal of any contaminated soil that may be encountered during future construction or development at the Site. It would be expected that operation of an SVE system would achieve cleanup goals in three to five years (depending on the extent of contamination immediately surrounding the USTs). Confirmation sampling would be

performed to confirm adequate treatment to below residential RBCs. Alternative in situ treatment technologies such as chemical oxidation may achieve the cleanup goals sooner but would also be less cost-effective under the assumed Site conditions.

Alternative 5—UST Decommissioning in Place and In Situ Treatment of Petroleum-Impacted Soil. Decommissioning the USTs in place would ensure that continued or future releases from abandoned USTs would not be possible at the Site. Active soil cleanup through SVE would require regular operation and maintenance to ensure long-term reliability, including maintenance of a power source, regular inspections and monitoring, periodic repair and replacement of associated equipment as needed due to wear and tear, extreme weather events, or accidental damage. The forecasted risks associated with climate change and natural hazards at the site are relatively low, with most likely impacts from wildfire, which could potentially impact the SVE system and lead to additional costs associated with restoration or replacement.

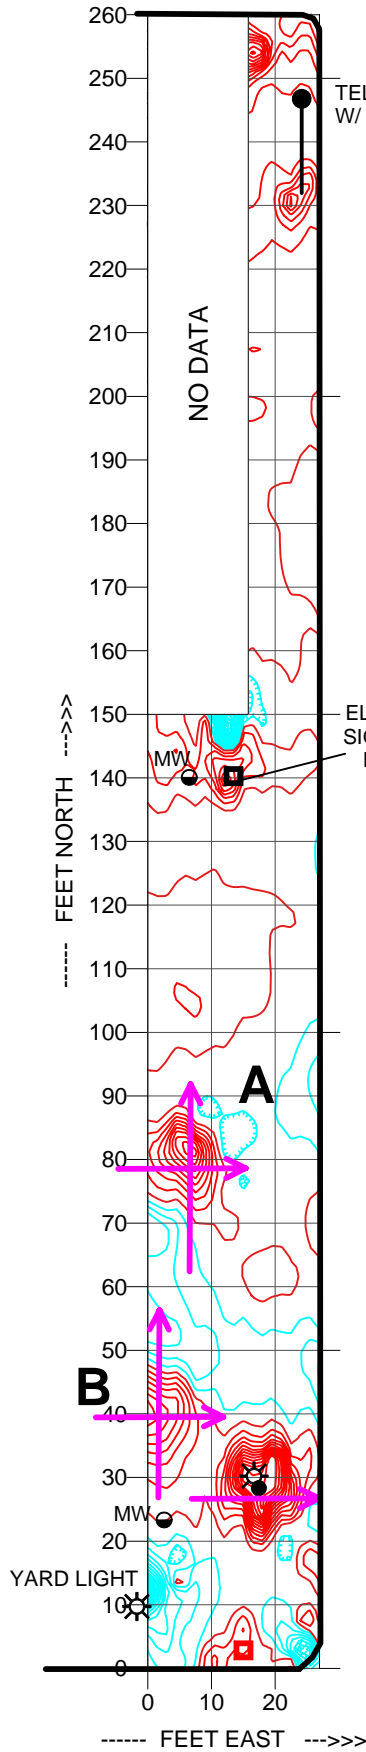
DATE: FEBRUARY 20, 2007 **SUBSURFACE MAPPING SURVEY** PROJECT No. 7756

SURFACE FEATURES IN BLACK
GPR LINES IN PINK

The subject property operated as a gasoline filling station from the 1940s to the 1990s. A GPR report conducted by GeoPotential in February 2007 confirmed the probable presence of two USTs on site; one to the north of the former Don’s Market structure, and one to the east of the former Don’s Market structure. Vent pipes were observed in the vicinity of the identified USTs. These tanks reportedly may still contain gasoline. No GPR was conducted on the west side of the structure. No environmental characterization or remediation has been conducted with regard to these tanks.

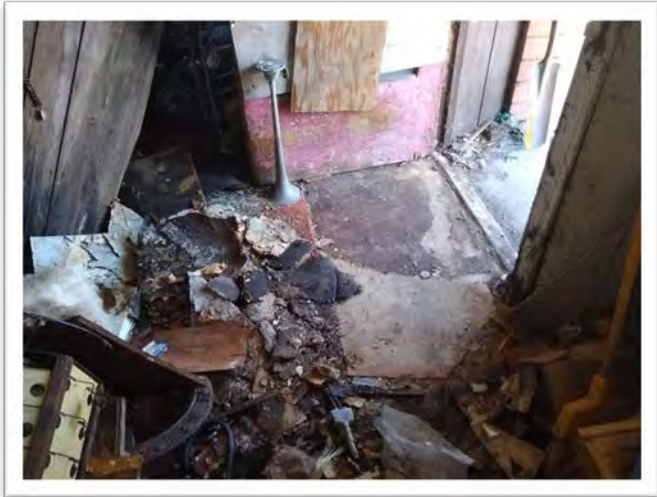
Sample 20-045A.1, Vinyl Floor, 20% Asbestos

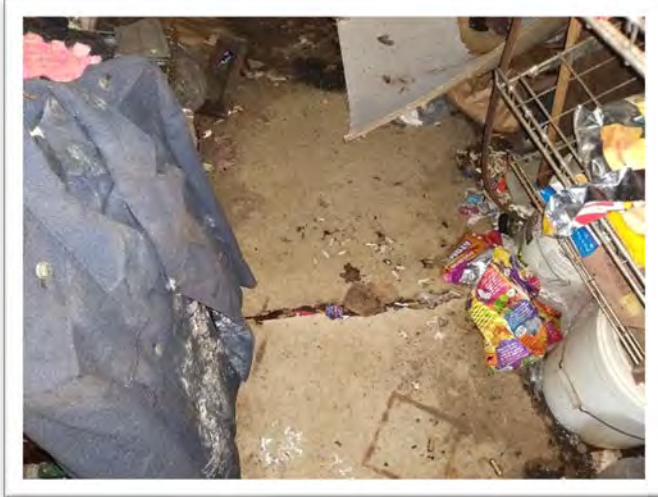
Sample 20-045A.2, Vinyl Floor, 20% Asbestos

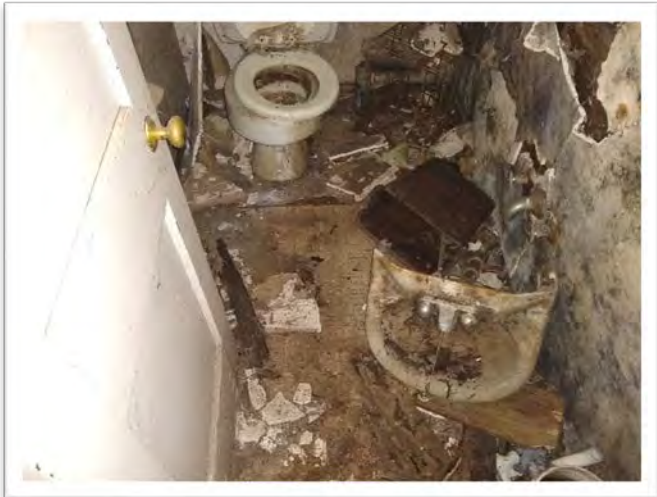
Sample 20-045A.3, Vinyl Floor, 20% Asbestos
Sample 20-045A.4, Vinyl Floor, 20% Asbestos

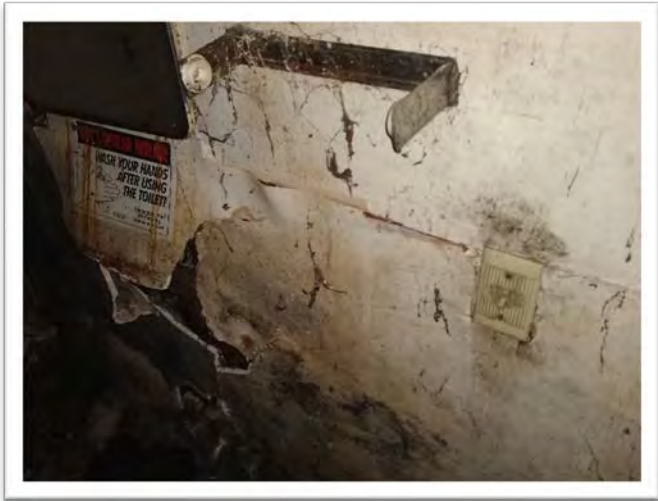
Sample 20-045A.11, Wall Materials, <1% Asbestos

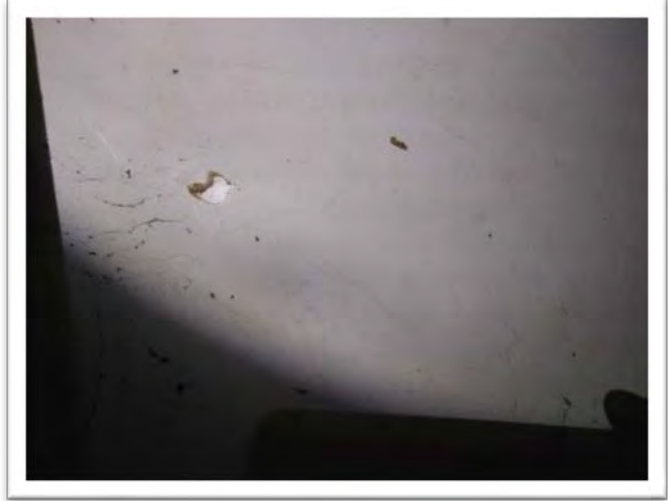
Sample 20-045A.12, Wall Materials, <1% Asbestos

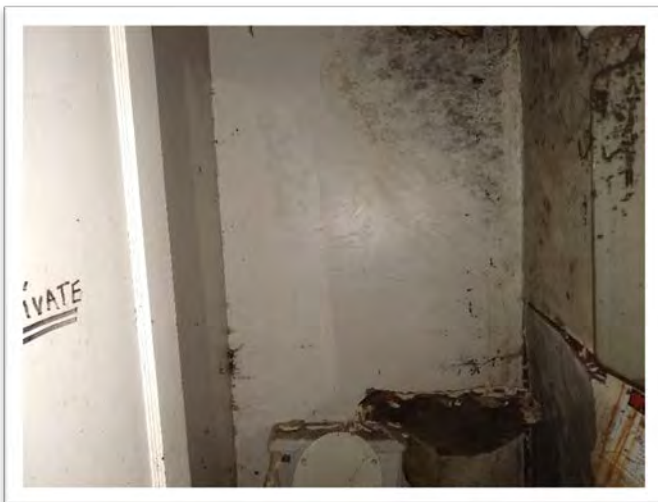
Sample 20-045A.13, Wall Materials, <1% Asbestos
Sample 20-045A.14, Wall Materials, 2% Asbestos

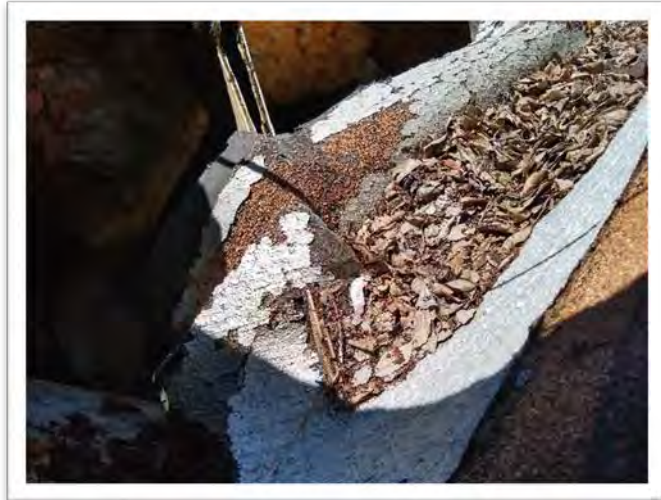
Sample 20-045A.19, Roof Coating, 2% Asbestos

Sample 20-045A.20, Roof Coating, 2% Asbestos

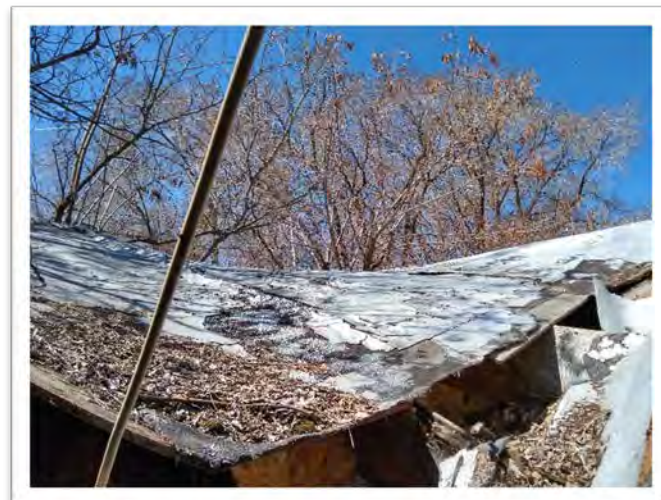
Sample 20-045A.23, Built-up Roof, <1% Asbestos

Sample 20-045A.24, Built-up Roof, <1% Asbestos

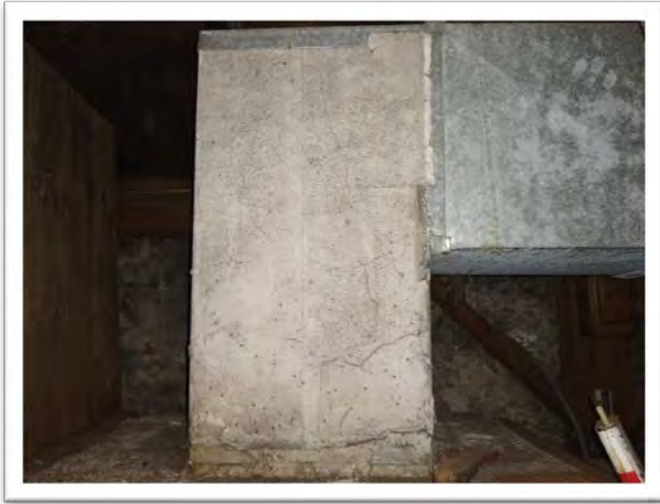
Sample 20-045A.41, Duct Insulation, 40% Asbestos

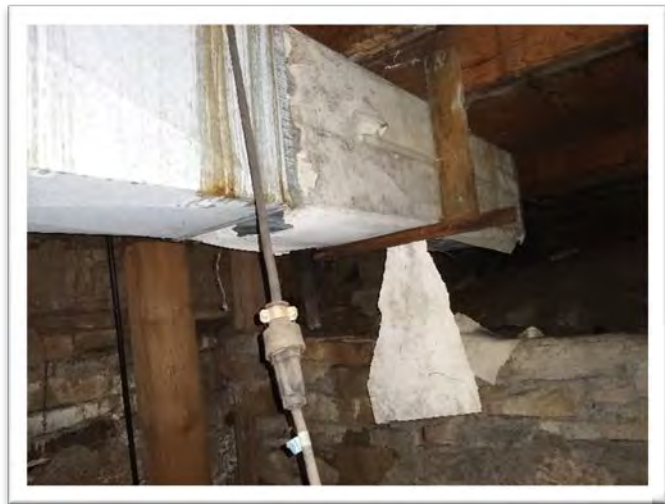
Sample 20-045A.42, Duct Insulation, 40% Asbestos

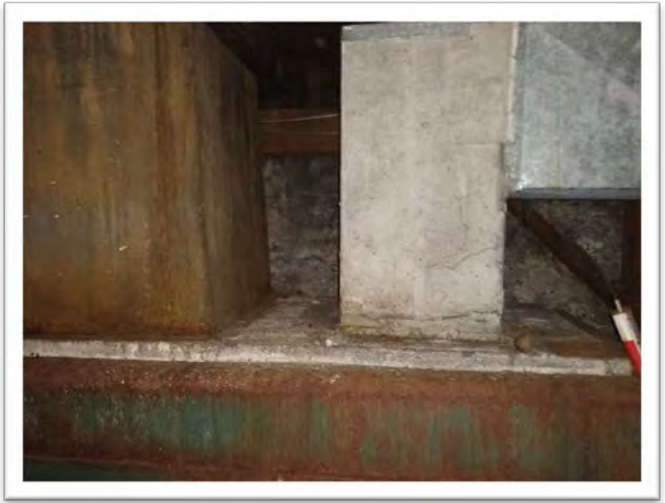
Sample 20-045A.44, Furnace Insulation, 40% Asbestos

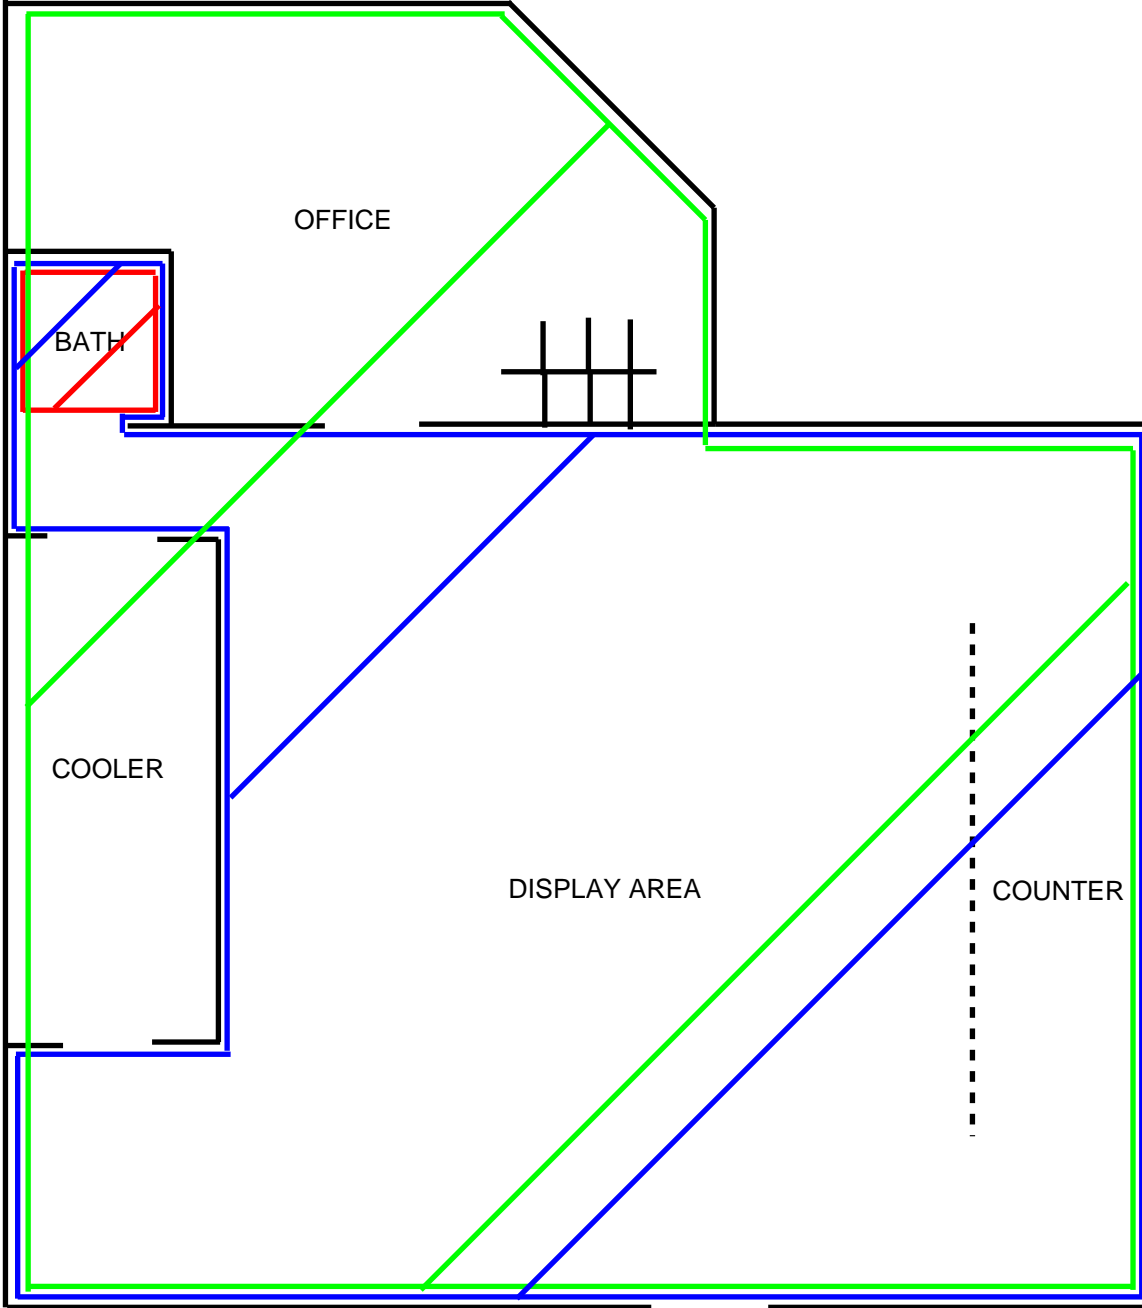
ASBESTOS MATERIAL LOCATION DIAGRAM
Don's Market Main Floor - 859 North G Street,
Lakeview

- = Asbestos Vinyl Floor Location
- = Asbestos Wall/Ceiling Location
- = Asbestos Roofing/Sealant Location

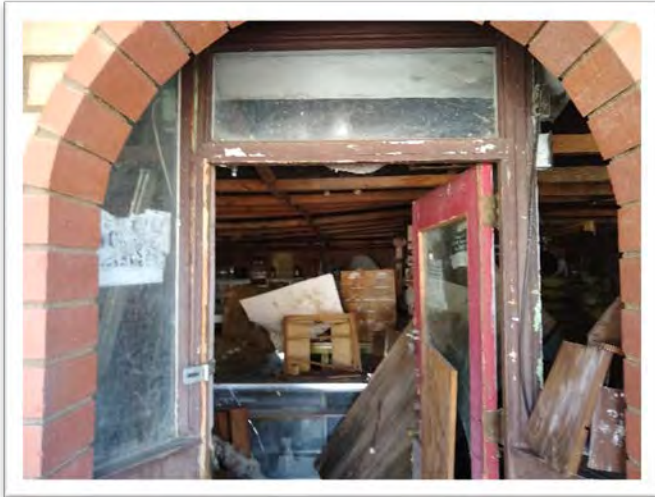
Sample 20-045A.L1, Brown Paint, 11,000 ppm Lead

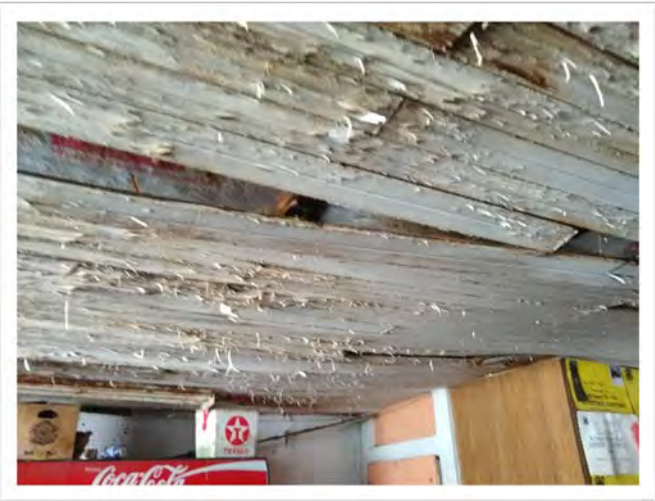
Sample 20-045A.L4, White Paint, 3,300 ppm Lead

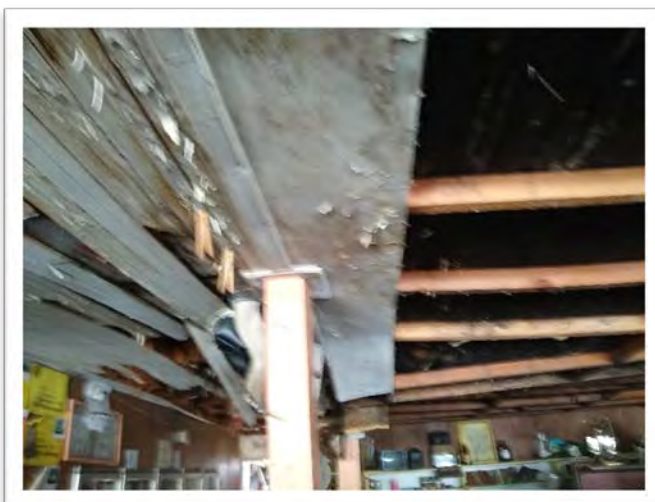
Sample 20-045A.L5, White Paint, 550 ppm Lead

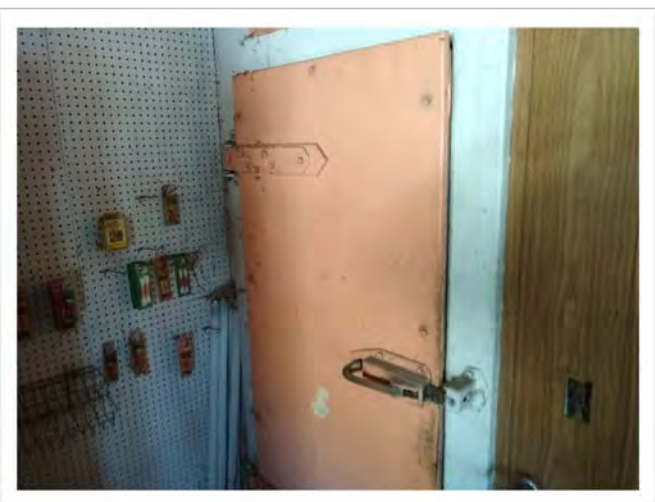
Sample 20-045A.L6, Orange Paint, 12,000 ppm Lead

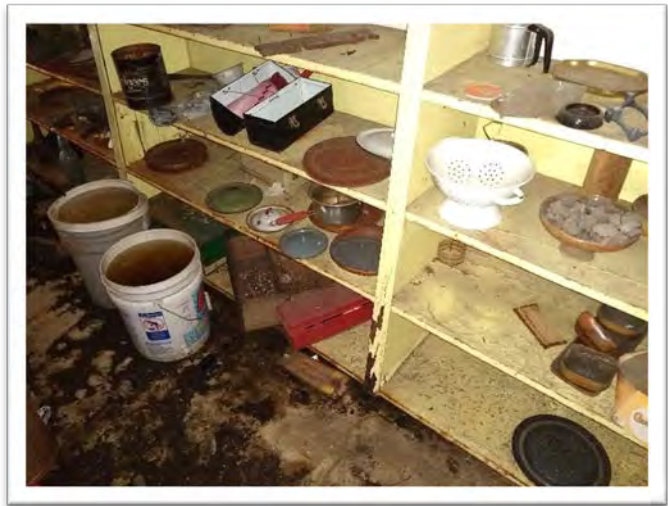
Sample 20-045A.L8, Yellow Paint, 68,000 ppm Lead

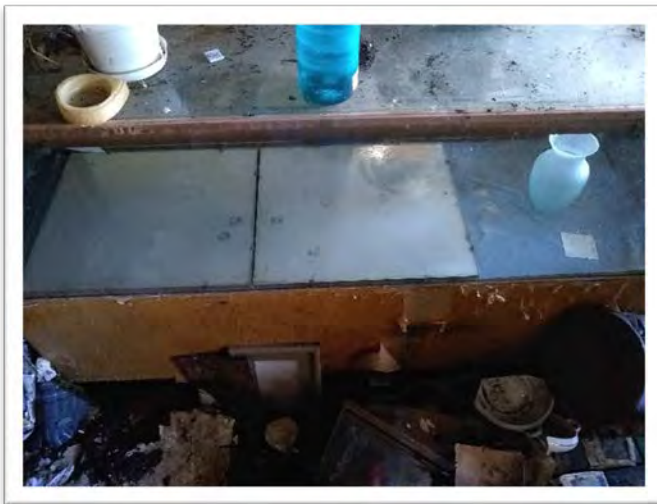
Sample 20-045A.L9, Yellow Paint, 700 ppm Lead

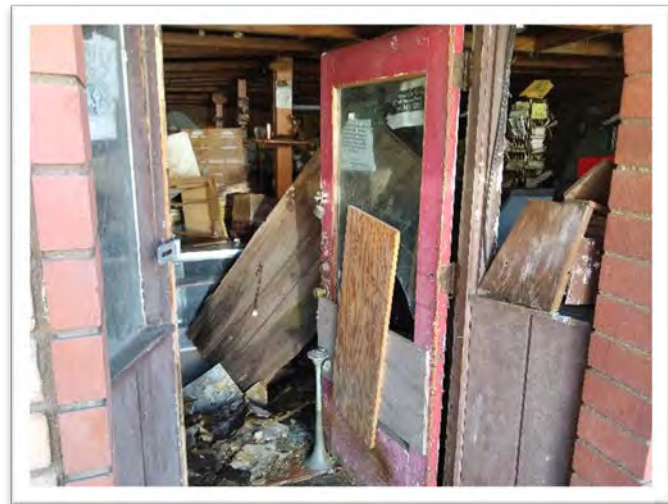
Sample 20-045A.L10, Red Paint, 16,000 ppm Lead
